TL23065B

Ingress Protection

EN 60529: 1992 + A2: 2013 (IP66 and IPX7)

D2xC Sounder and Beacon

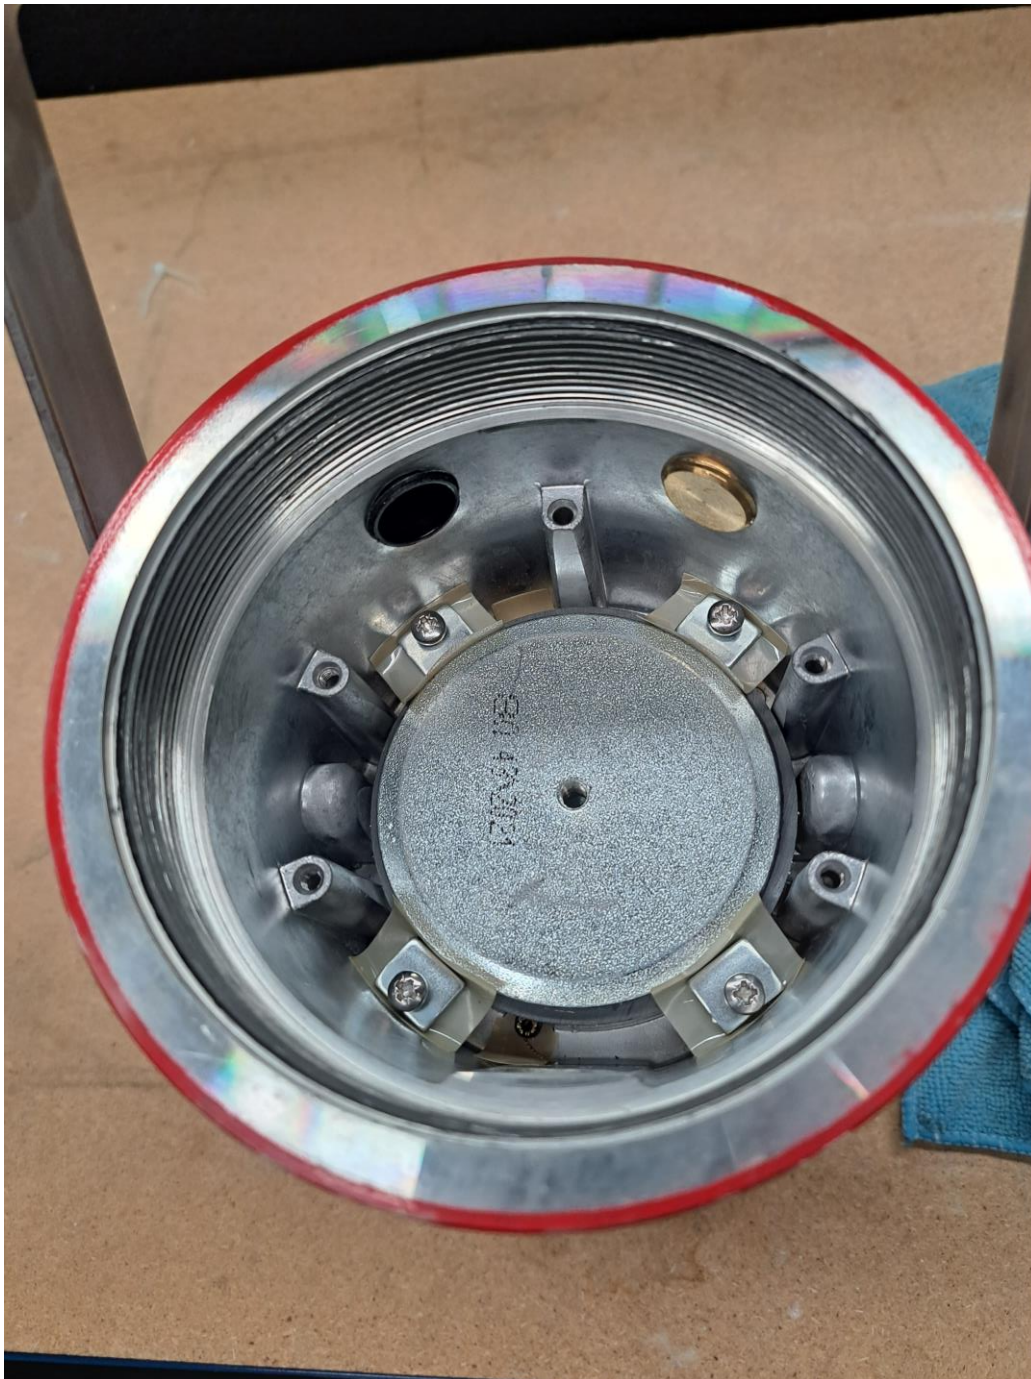
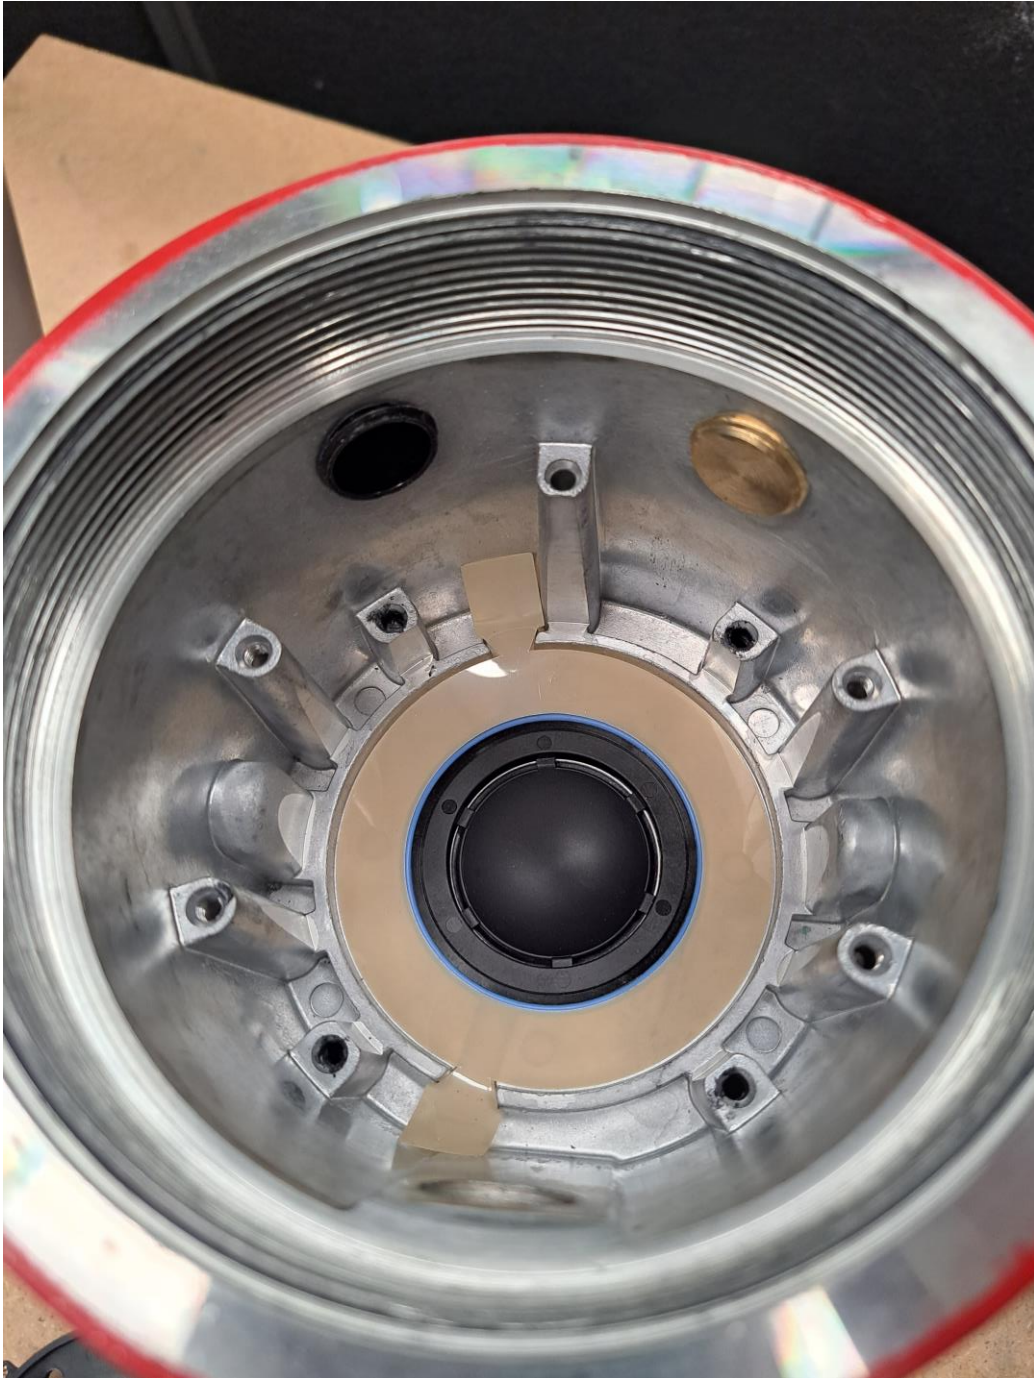
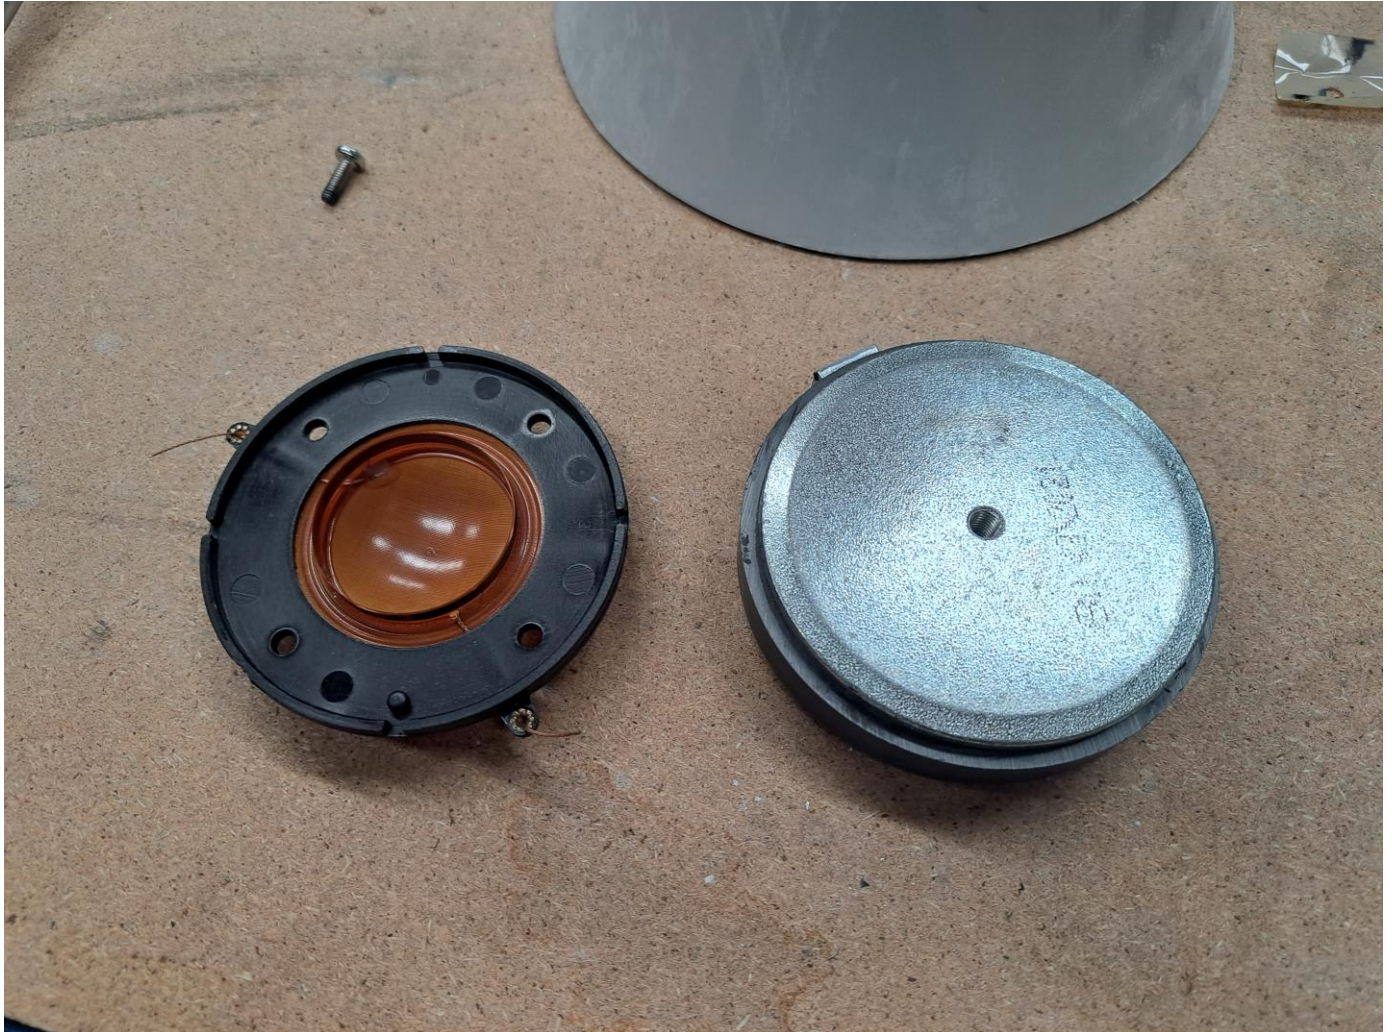
The enclosure under test was supported inside the test chamber and the pressure inside the enclosure was maintained below the surrounding atmospheric pressure by a vacuum pump.

The extraction rate was less than 40 volumes per hour so the test was continued for a period of 8h.

No dust was found to have entered the enclosure.

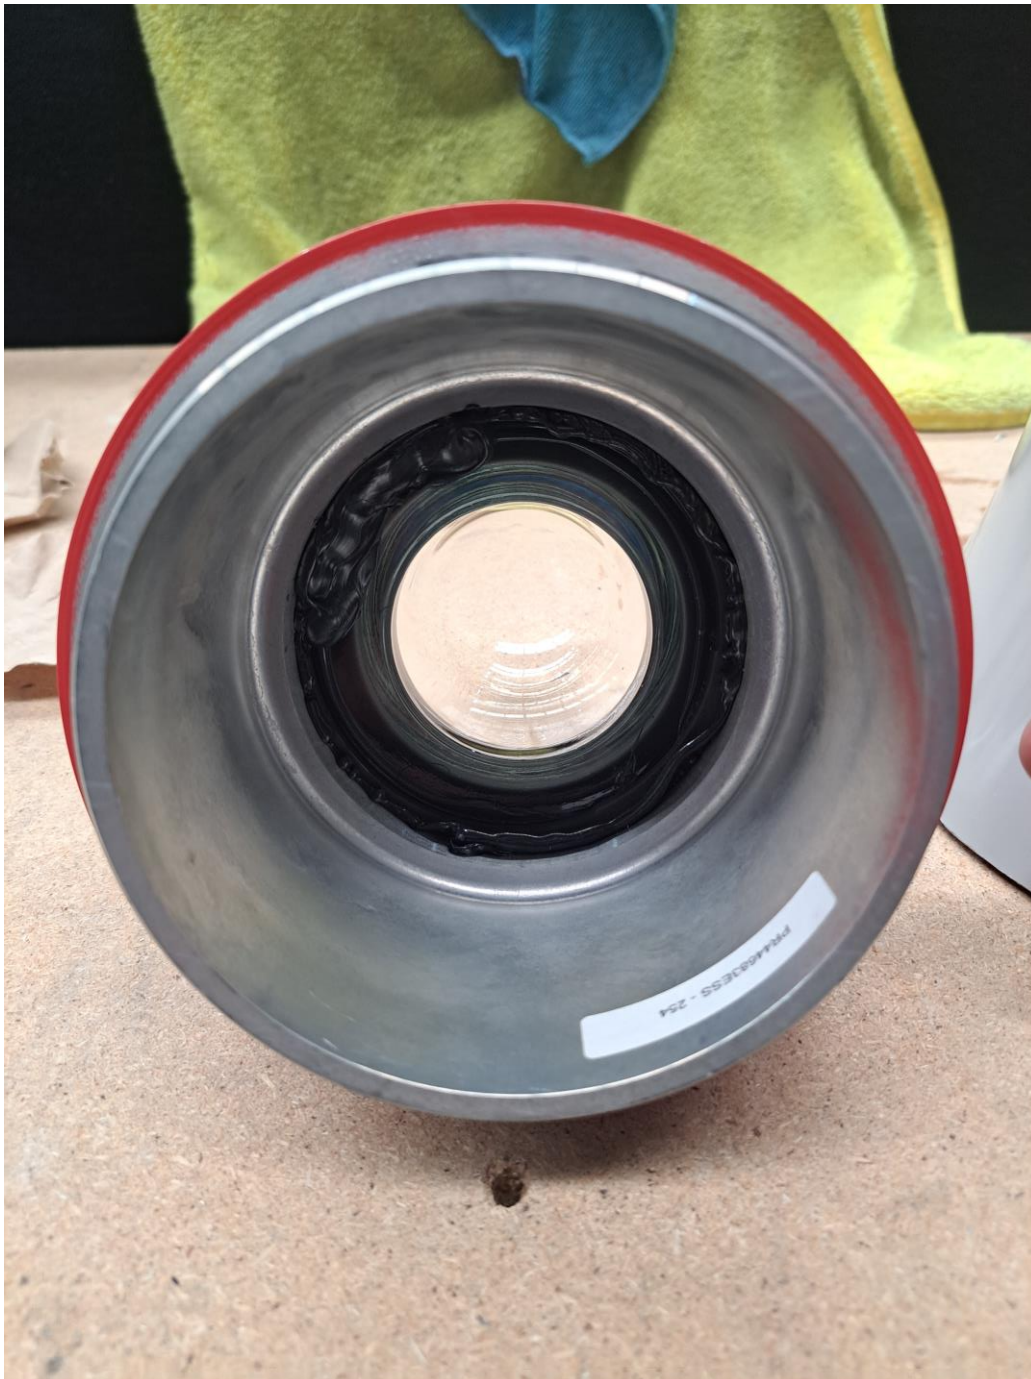
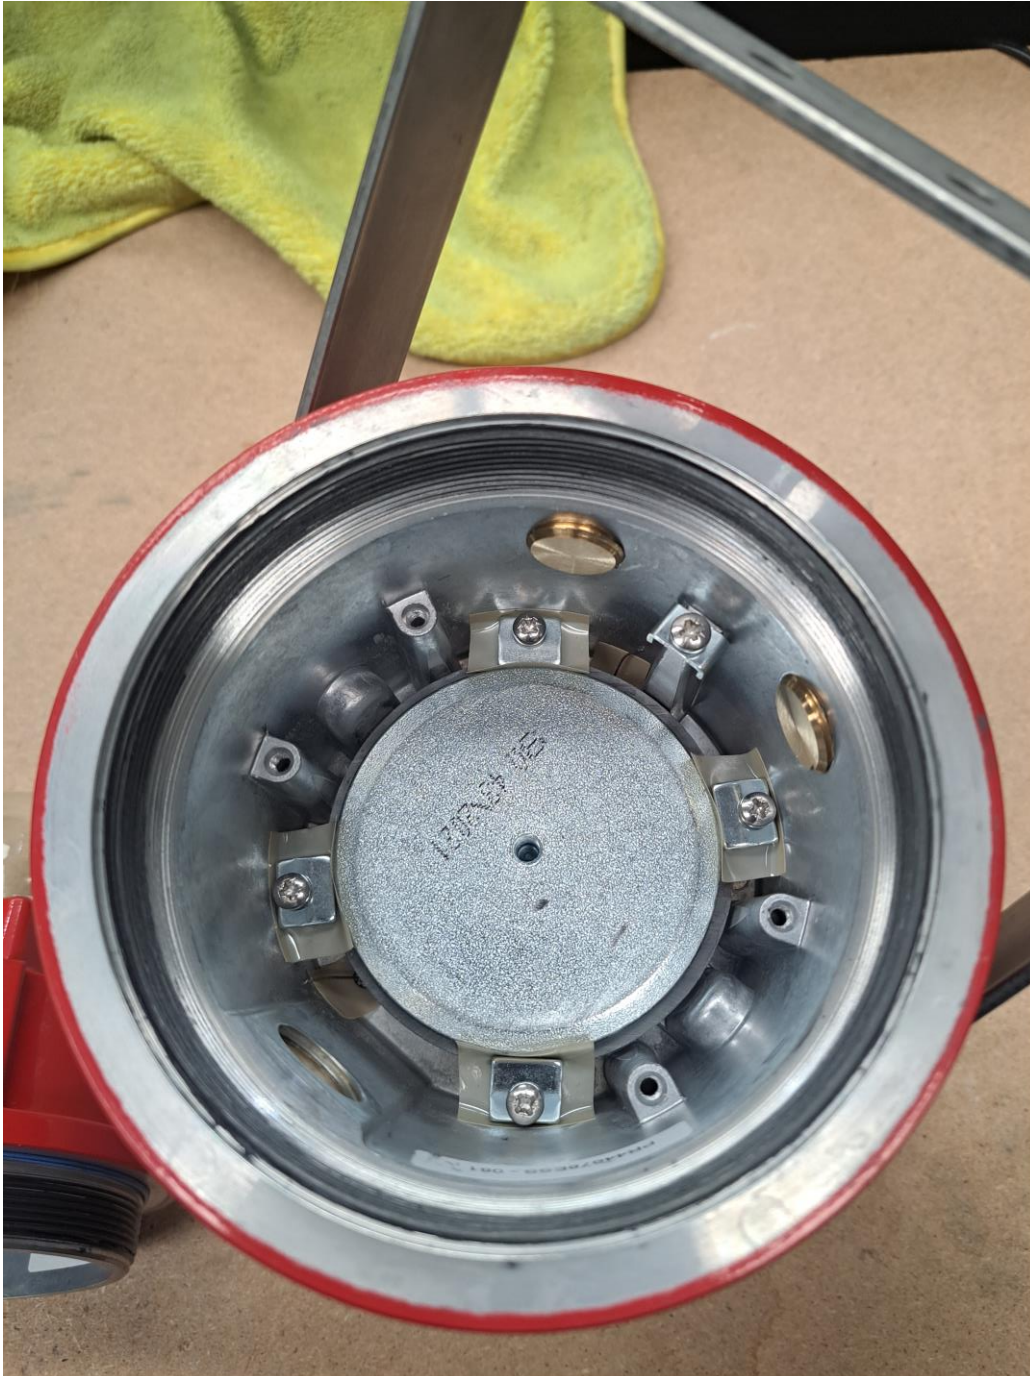
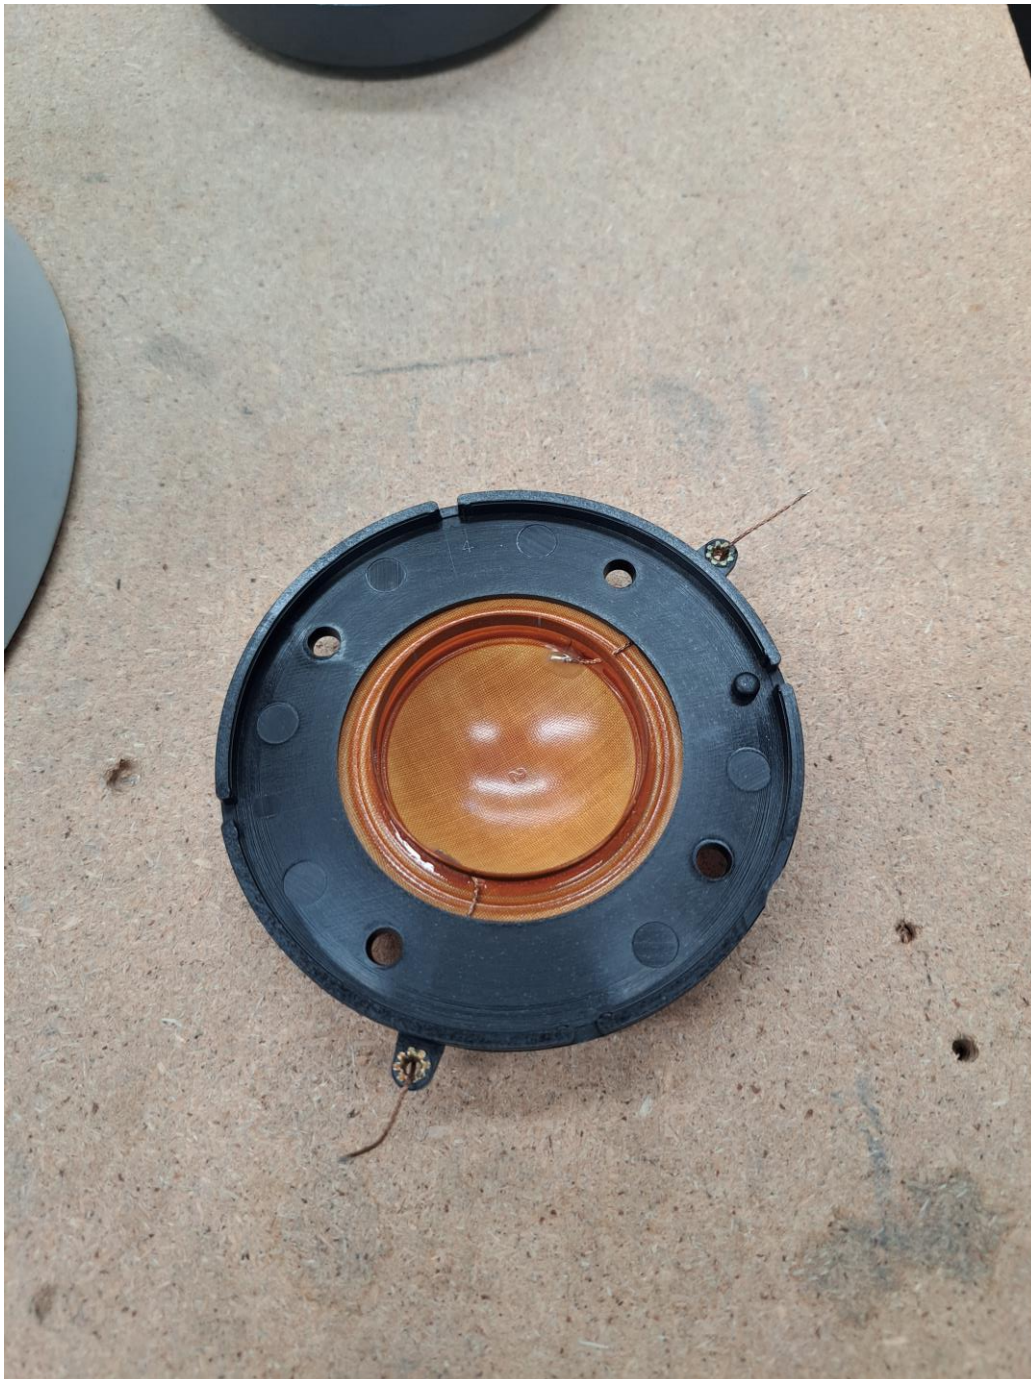
The enclosure under test was sprayed from all practical directions at a distance of 2500mm to 3000mm with water through a 12.5mm nozzle at a water pressure of 100 litres/min. The equipment under test was sprayed for a period of no less than 3 minutes at each direction.

The client stated the last barrier within the unit that provided protection against ingress was the diaphragm and hard plastic casing, this was mounted to the base on the beacon side the enclosure below the speaker. Provided no water surpassed this point then it would not be present where electronics would be mounted. The enclosure was opened after the test and there was no ingress of water passed the diaphragm and hard plastic case, the water shown in the picture below was on the underside of these.

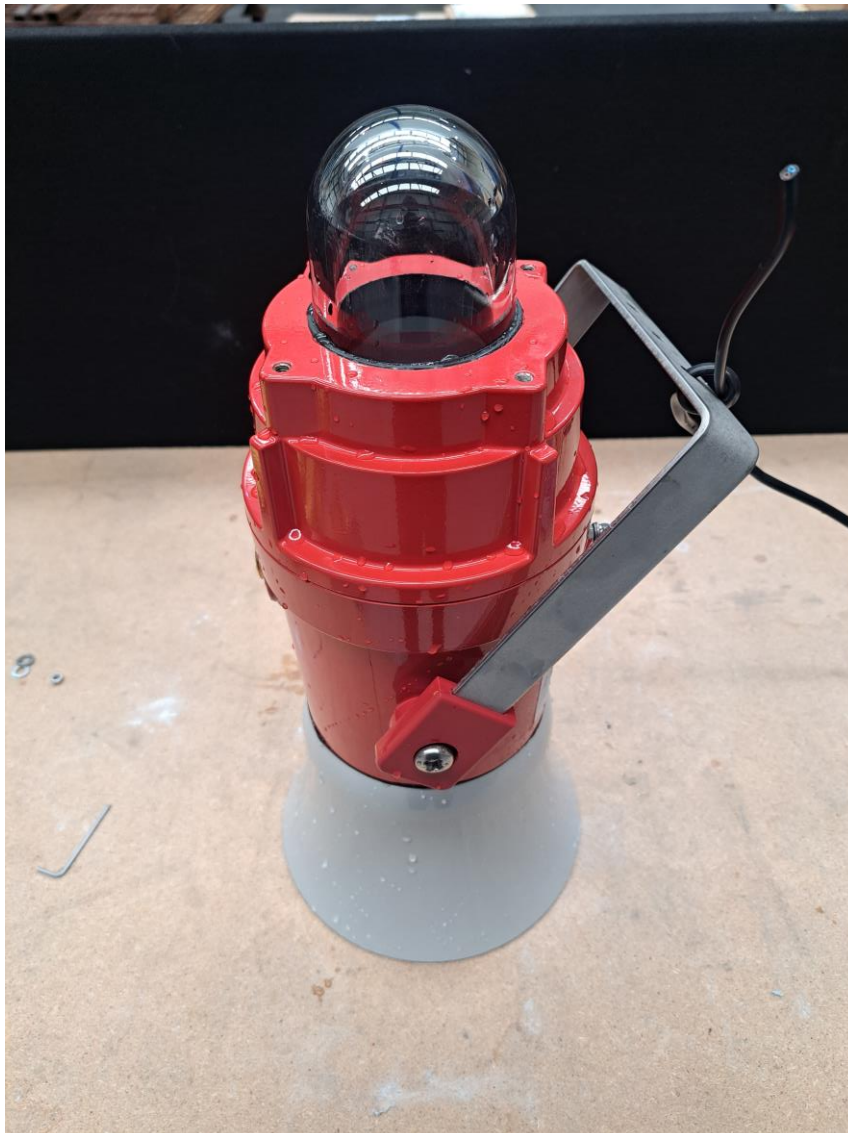
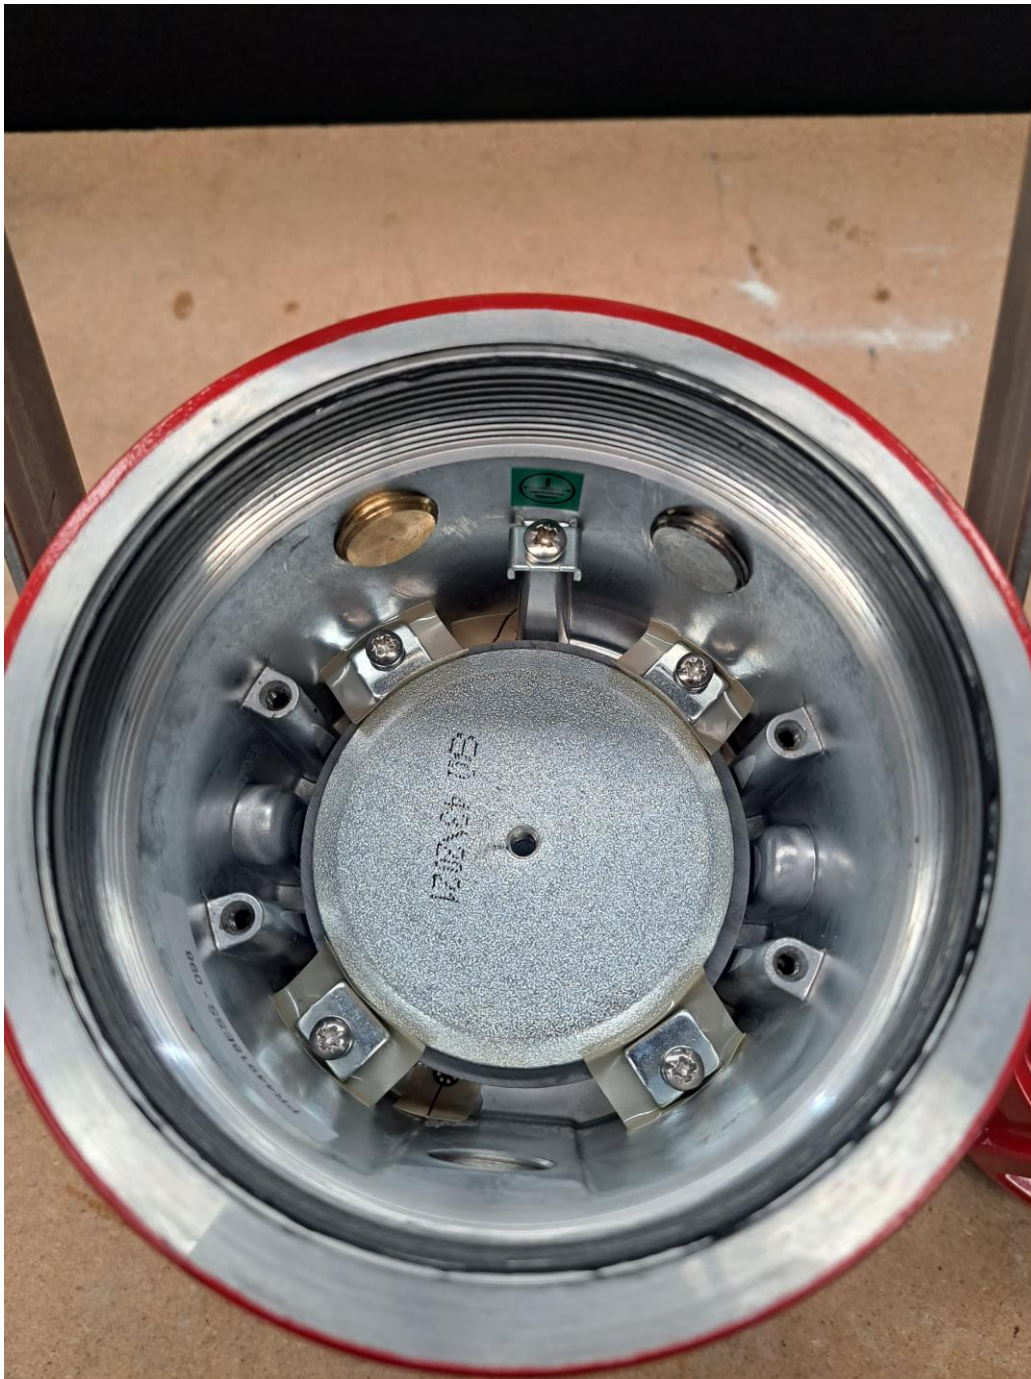
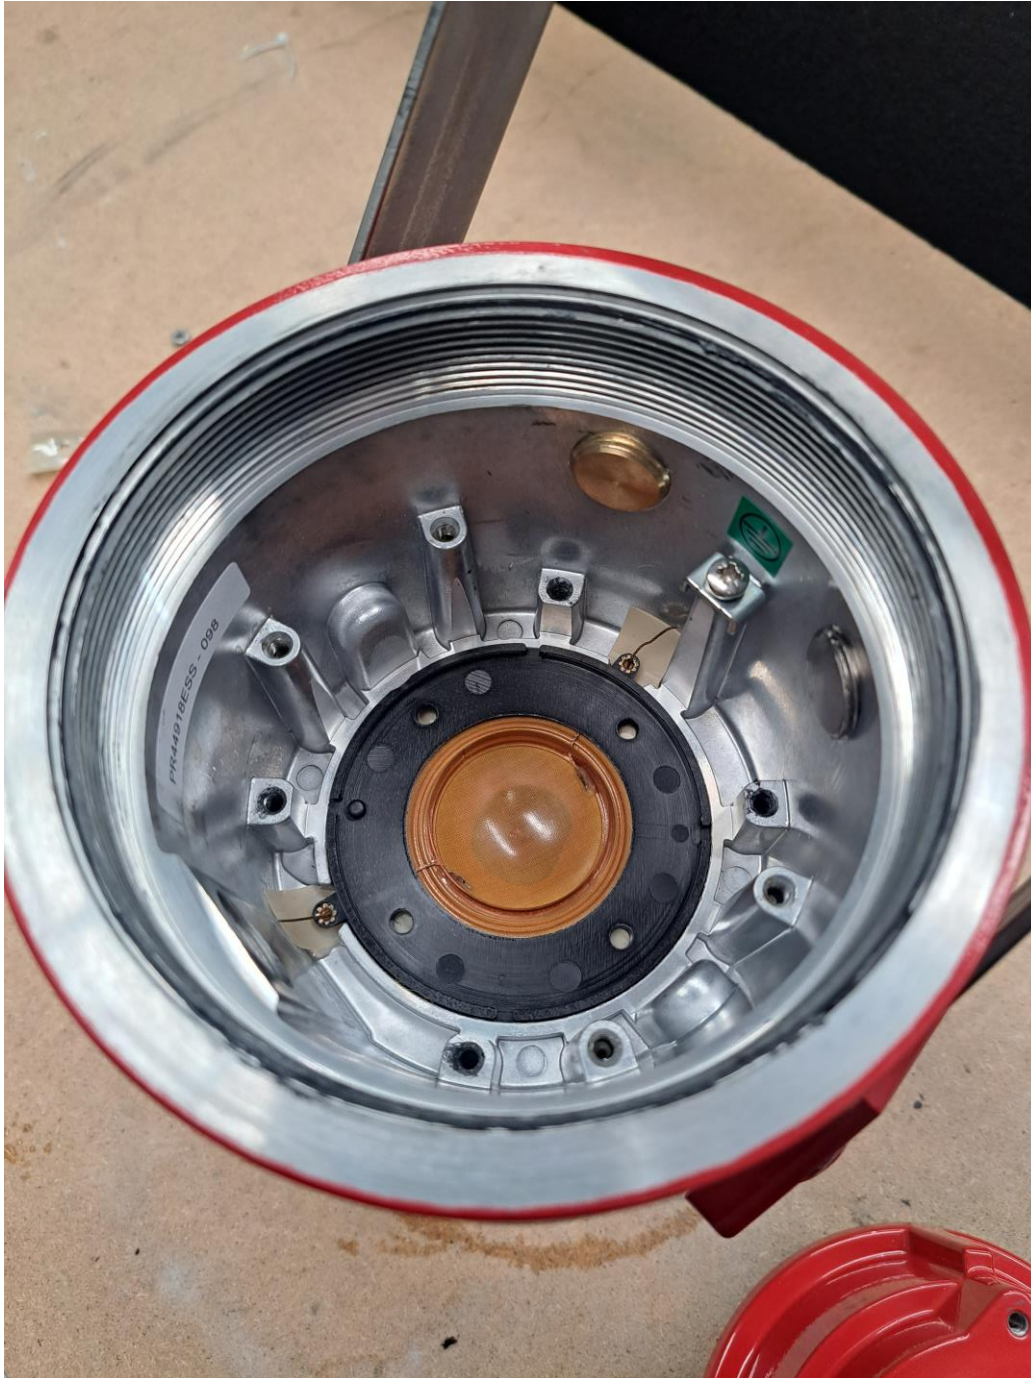
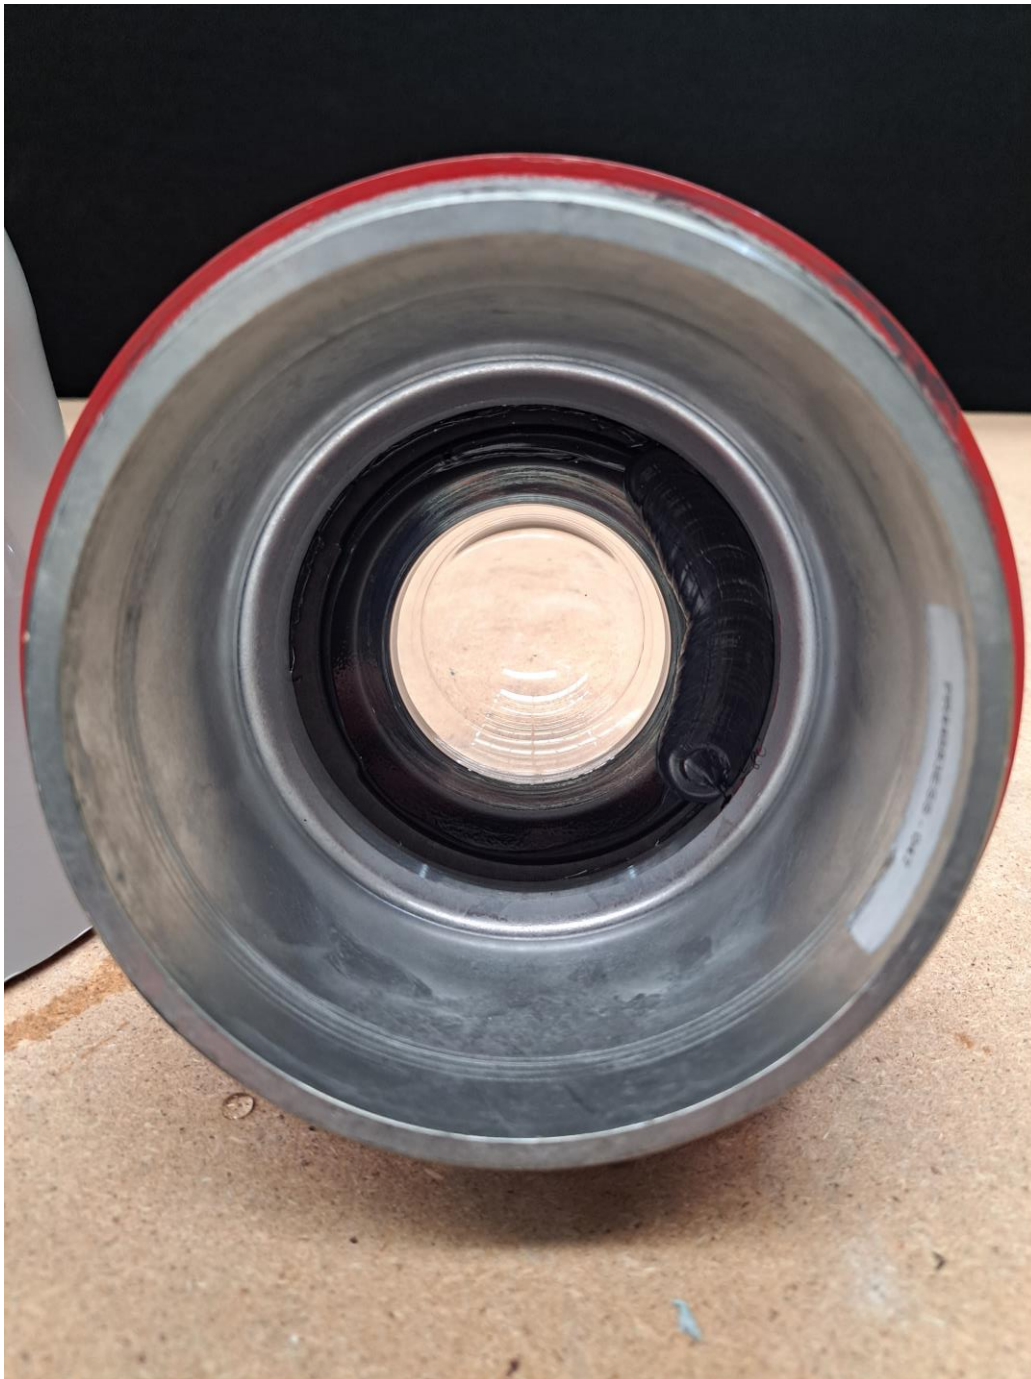
The enclosure under test was placed in its normal operating orientation into a tank filled with water to a depth of 1 metre for 30 minutes.

The client stated the last barrier within the unit that provided protection against ingress was the diaphragm and hard plastic casing, this was mounted to the base on the beacon side the enclosure below the speaker. Provided no water surpassed this point then it would not be present where electronics would be mounted. The enclosure was opened after the test and there was no ingress of water passed the diaphragm and hard plastic case, the water shown in the picture below was on the underside of these.
